### **APOLLO SPACECRAFT**

**REPORT OF PANEL 5  
ORIGIN AND PROPAGATION OF FIRE  
APPENDIX D-5  
TO  
FINAL REPORT OF  
COLLO 204 REVIEW BOARD**

## **ORIGIN AND PROPAGATION OF FIRE**

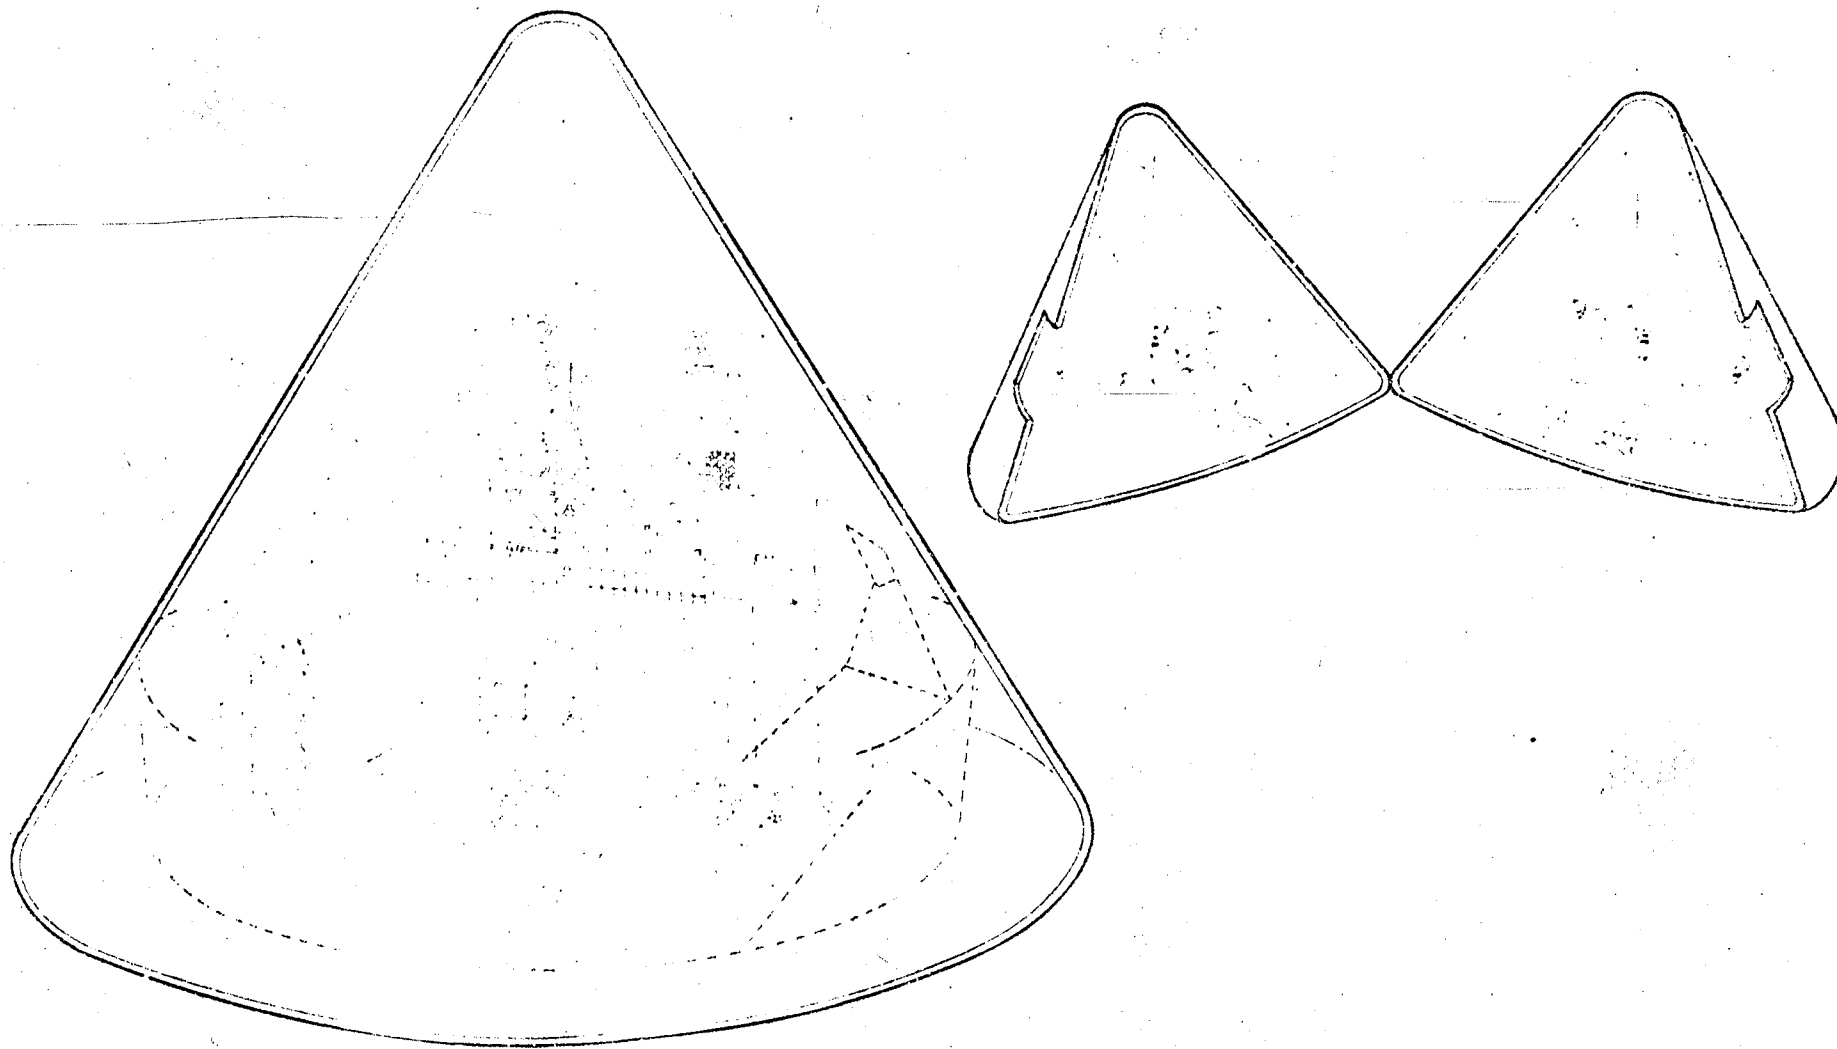
ENCLOSURE 5-7

b. From observations of post-fire damage and witness statements, the fire first appeared to be at the lower portion of the left side of the C/M, presumably near the lower left corner (Enclosure 5-7). The slow rate of rise of recorded cabin pressure caused by the heat released by the fire suggests that the fire was not intense until about 23:31:12 GMT (Enclosure 5-8). This slow rate of pressure rise is consistent with the view that the early fire was either located in a zone containing little combustible or one containing much bare aluminum structure which could absorb an appreciable portion of the heat. The first significant indication of pressure rise was shown by telemetry data at 23:31:08.4 GMT.

VIEW OF LOWER LEFT HAND CORNER

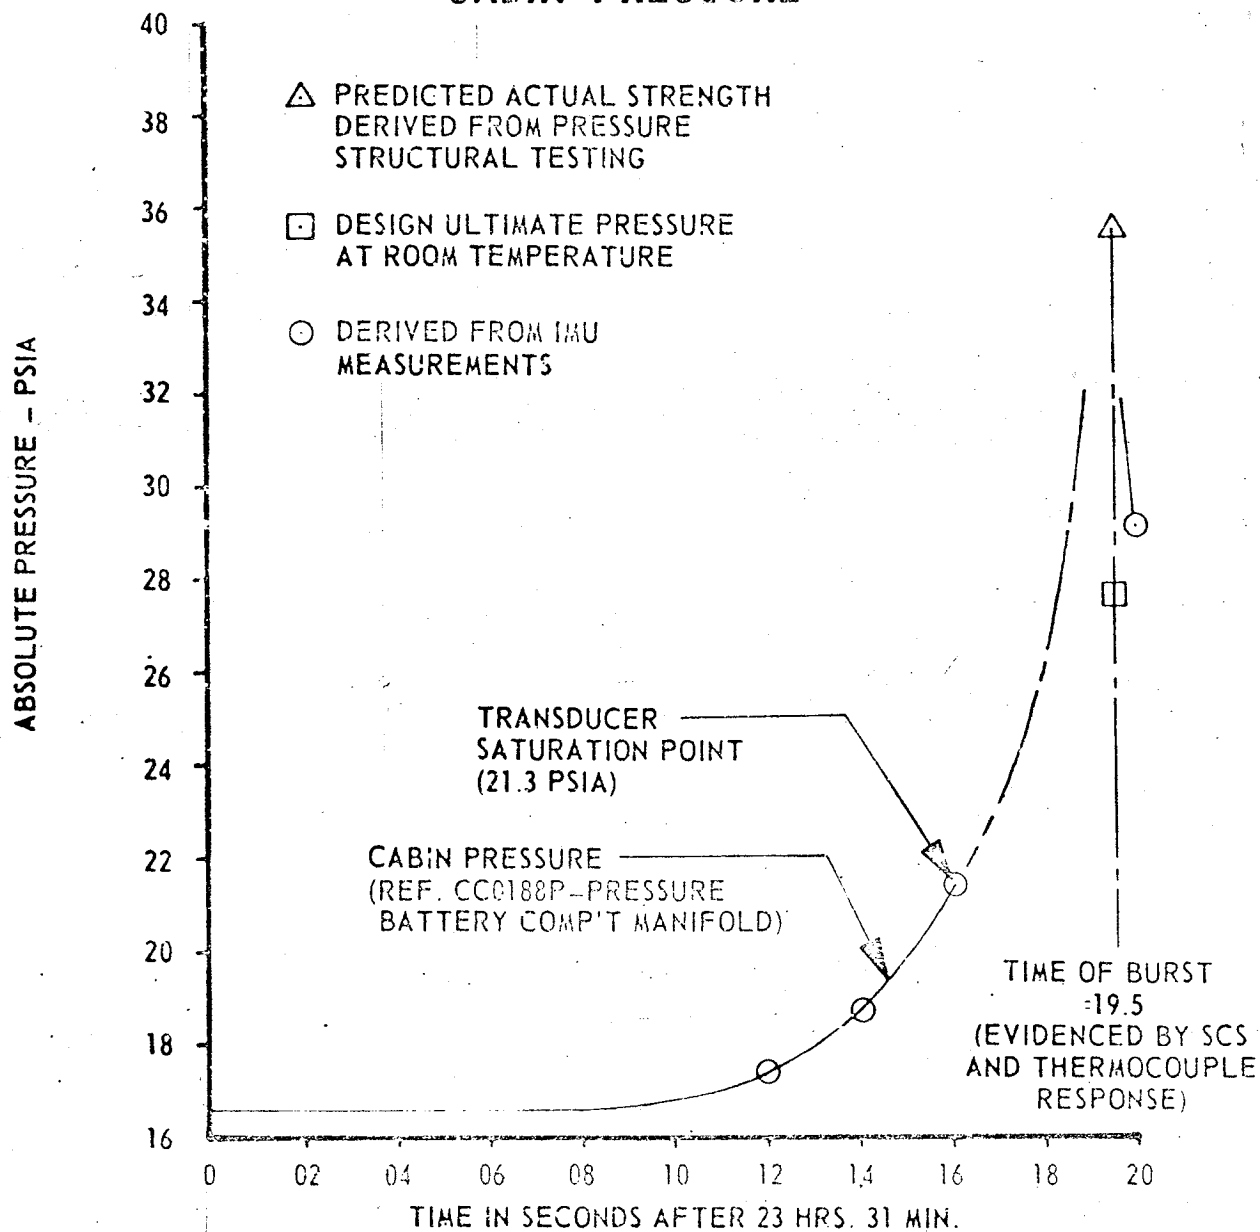
e. The second stage of the fire began at about 23:31:19 GMT when the cabin pressure record can be interpreted to mean that the pressure had risen to a range of 29 to perhaps 37.7 pounds per square inch absolute (psia). This is the estimated failure range of the pressure vessel (Enclosure 5-8). This pressure would have resulted from the burning of three or four ounces of nylon, assuming adiabatic conditions. Cooling of the cabin atmosphere by the structure, would substantially increase this estimated quantity.

CABIN PRESSURE CHART

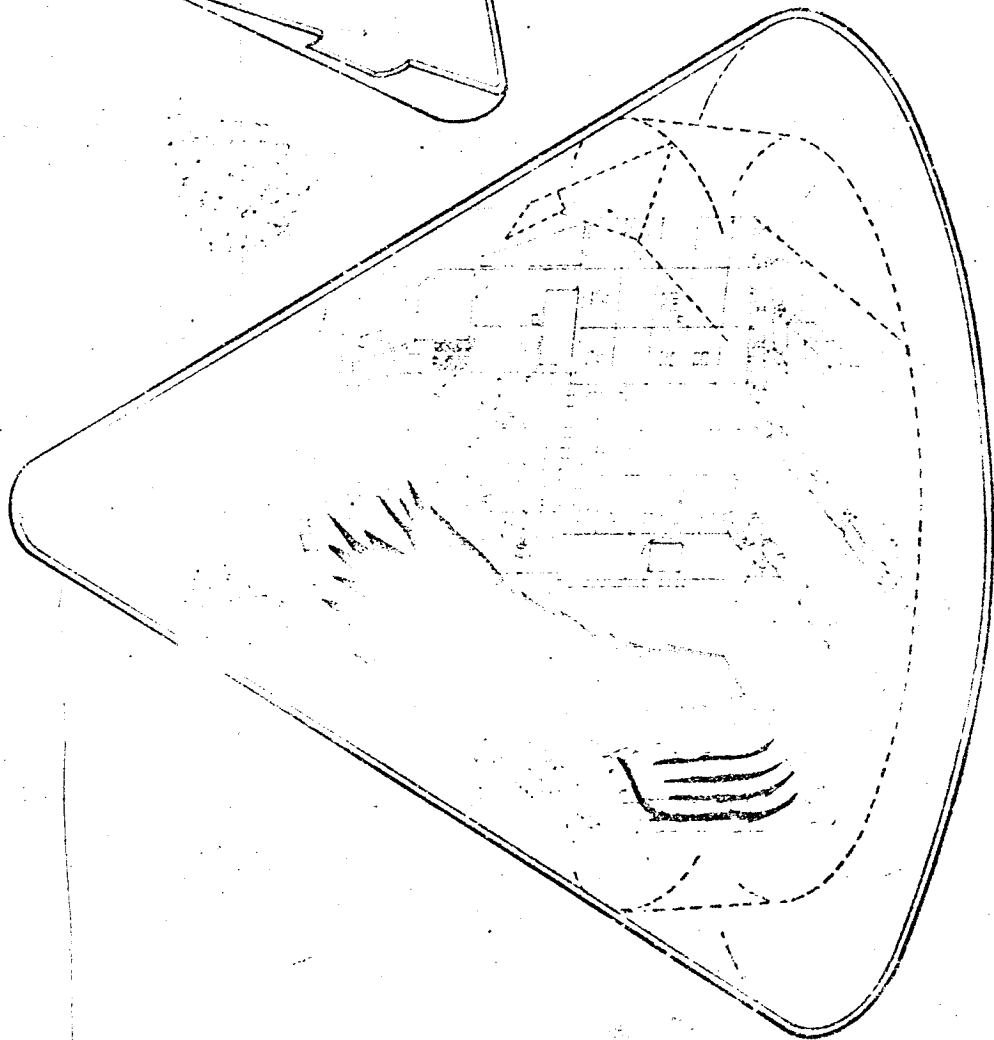
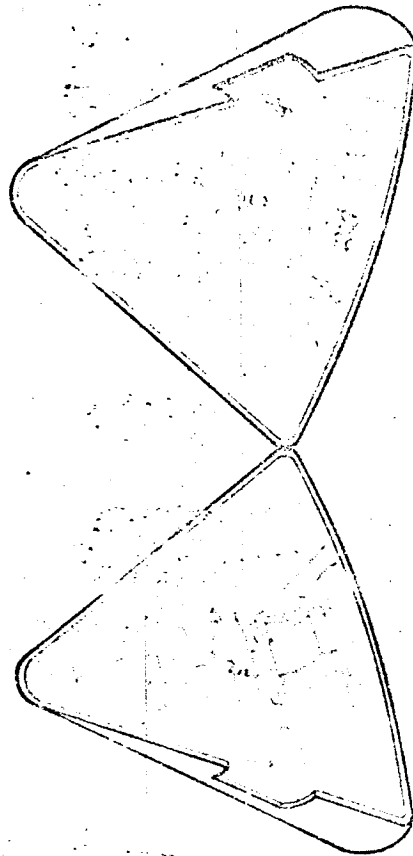
ENCLOSURE 5-9

FIRST PHASE OF FIRE

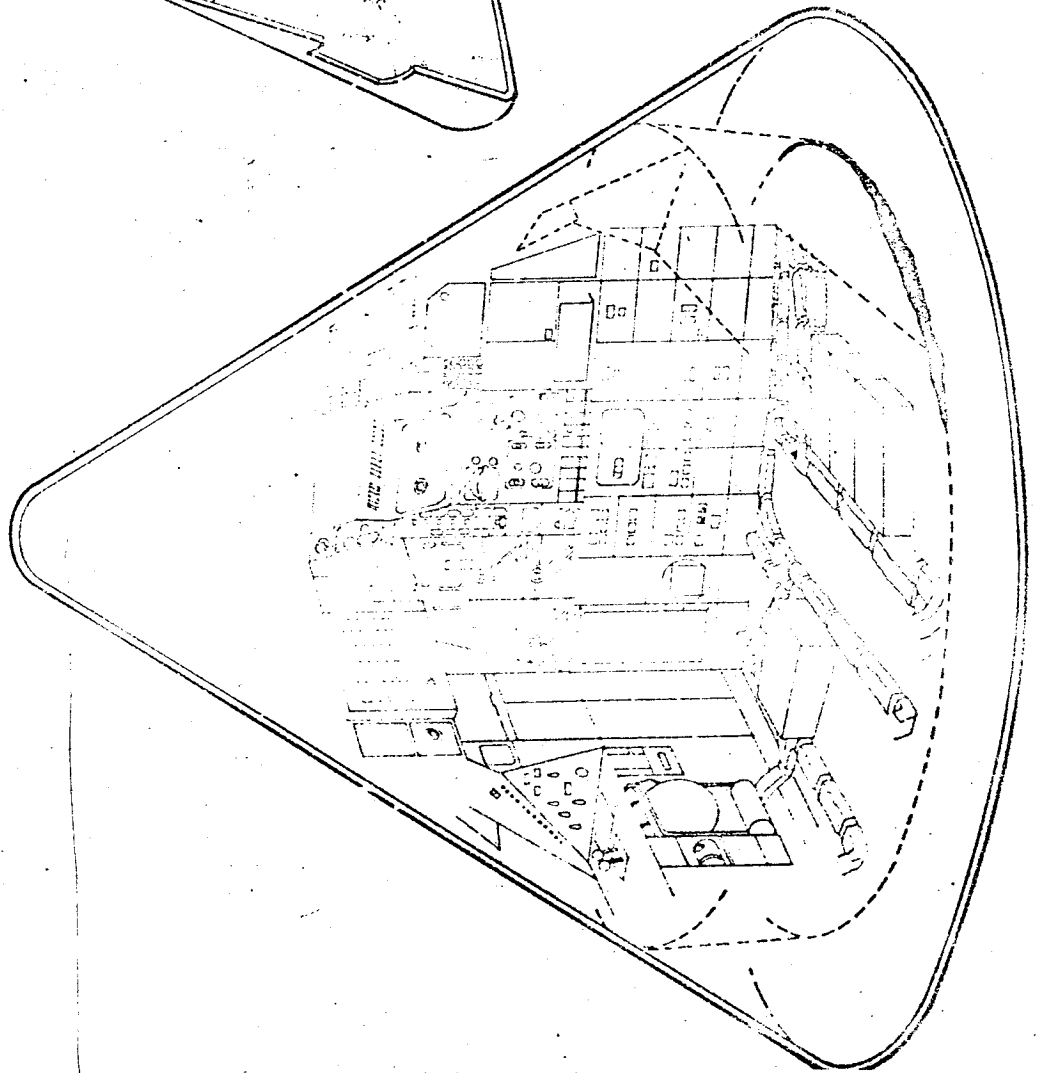
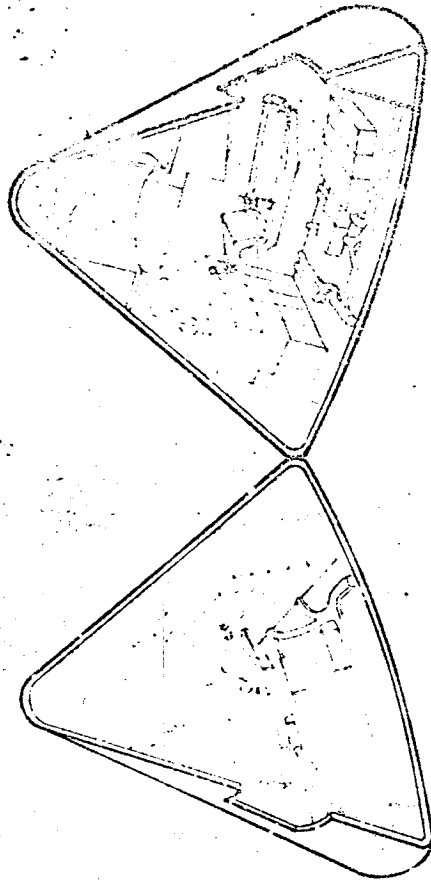
ENCLOSURE 5-12

f. A major failure in the aft bulkhead occurred at the junction of the wall and aft bulkhead in the vicinity of the umbilical (Enclosure 5-12). Cabin gases and flame flowed in the direction of the break in the floor. The flames, debris, and oxygen flowed into the toroidal space between the pressure shell and the heat shield where the thermocouples registered rapidly rising temperature at 23:31:20 GMT. Flames in the toroidal space burned and melted components of the Reaction Control System and the insulation and honeycomb structure of the aft heat shield. These flames also poured from access hatches in the crew compartment heat shield and set fire to combustibles situated on and around the spacecraft at levels A-8 and A-7. These fires endangered pad personnel and impeded rescue.

FIRST PRESSURE VESSEL FAILURE

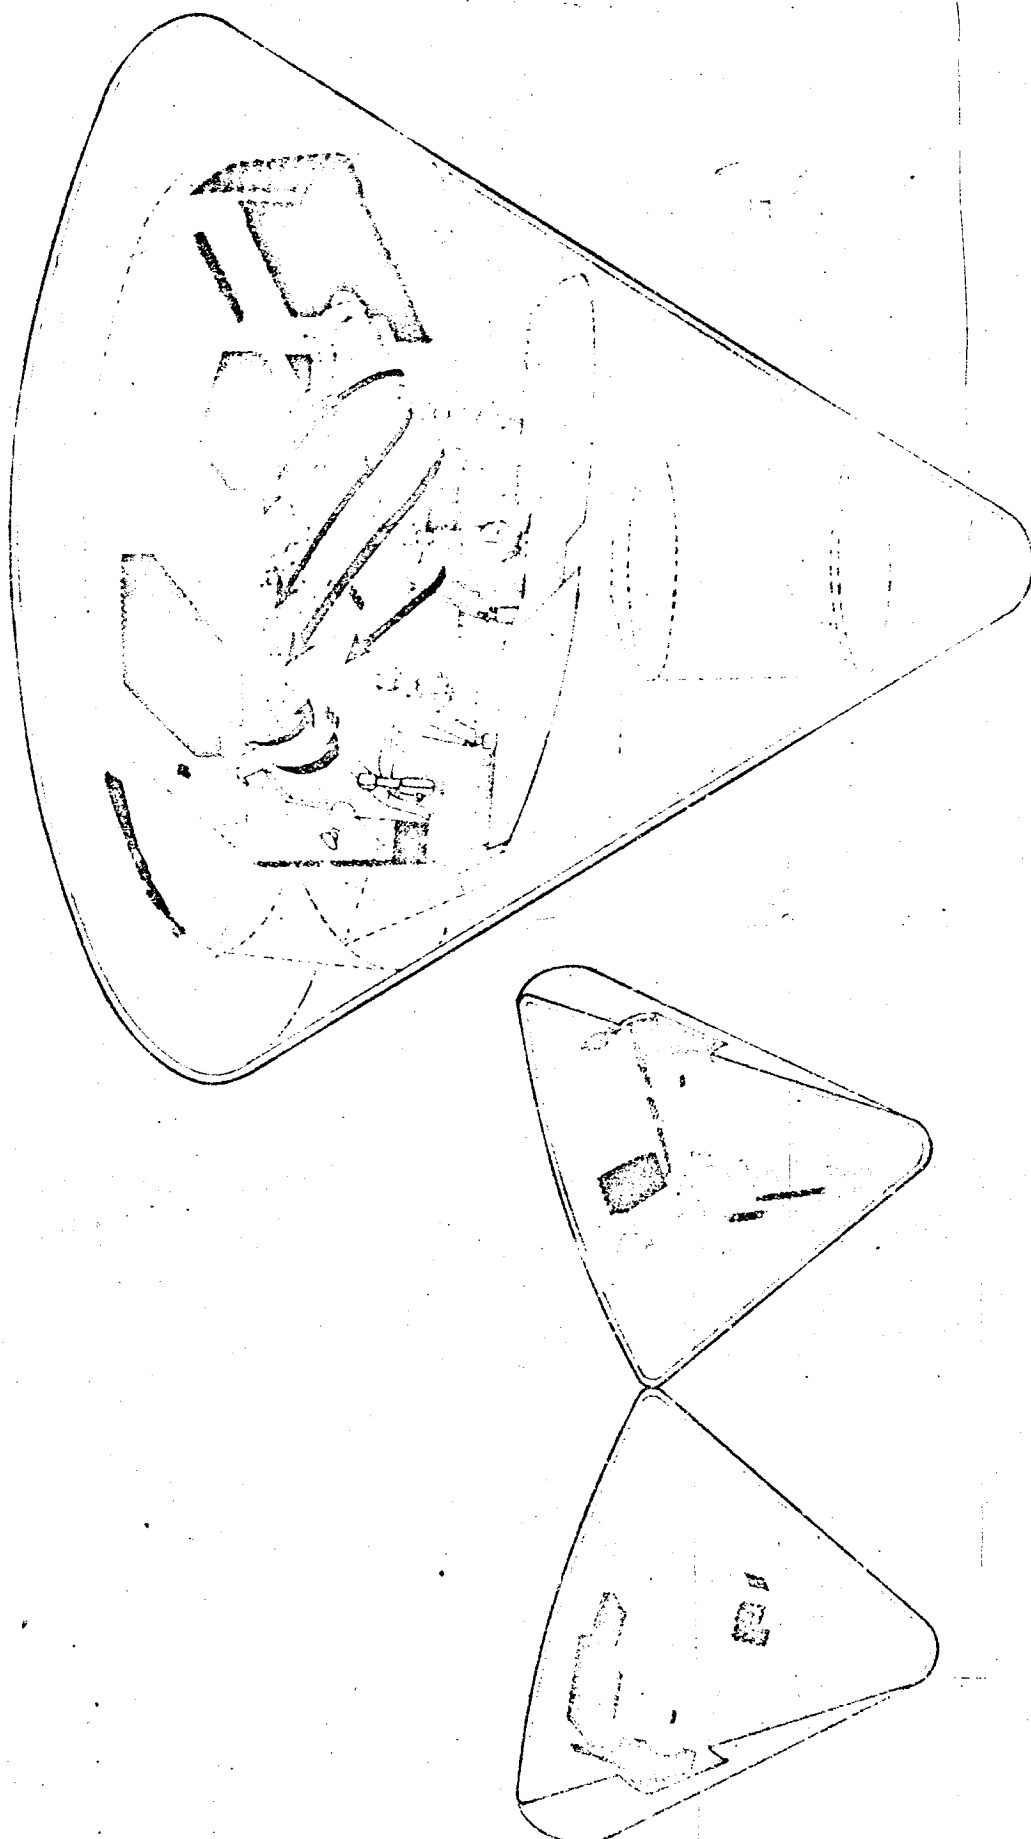
ENCLOSURE 5-13

g. After cabin failure, the gas flowing toward the floor break swept the flames to other combustibles and increased the rate of fire spread markedly. Flames rising above the couches were directed into a horizontal plane to spread the fire over the couches. Examination of the couches and astronauts' suits after the fire indicates the movement of these flames in the manner indicated in Enclosure 5-13. Flame damage to the suits, harness, and helmet visors show that it was most severe for the Command Pilot and least for the Pilot. Witnesses at monitors of the television camera mounted outside the cabin hatch view port reported movement of flame from left to right inside the cabin.

SECOND FIRE PHASE OVER COUCHES

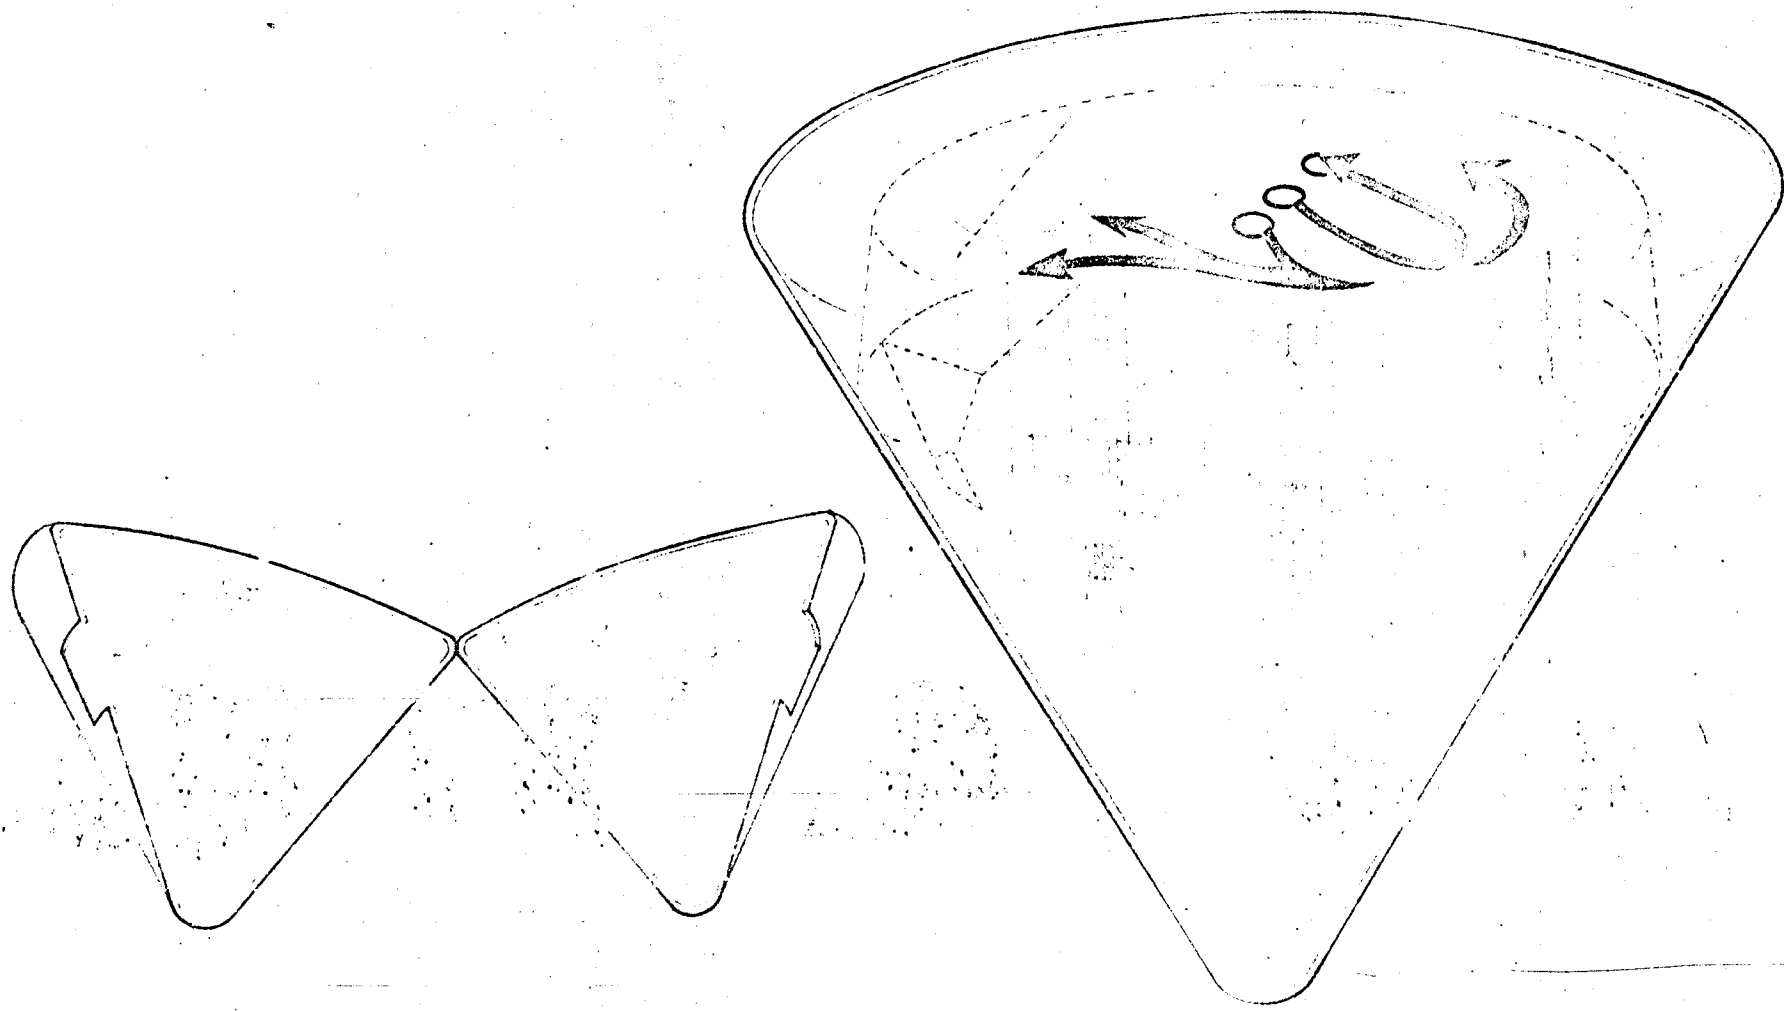
ENCLOSURE 5-15

j. Some of the fire below the couch also swept in the direction of the floor break (Enclosure 5-15). Fire damage to the three helmet covers lying on the floor below the Senior Pilot's (middle) couch indicated that some of this flame spread around the lithium hydroxide (LiOH) canister storage box to the left of the helmet covers (Enclosure 5-16). Fire damage to these covers is greatest on their left sides where the flames impinged. The fire damage to the helmet covers, shown in this photograph, is consistent with this view of the path taken by the flames at this location. Enclosure 5-17 is a view of the helmet cover which lies closest to the hatch. Because the camera faces the hatch, the left side of the C/M is on the viewer's right.

FIRE ON C/M FLOOR  
2ND FIRE PHASE
